## Sustained casing pressure and gas bubbles successfully eliminated in Permian Basin well abandonment (P&A)

MAJOR OPERATOR | 10 SEPT 2021 | PERMIAN BASIN

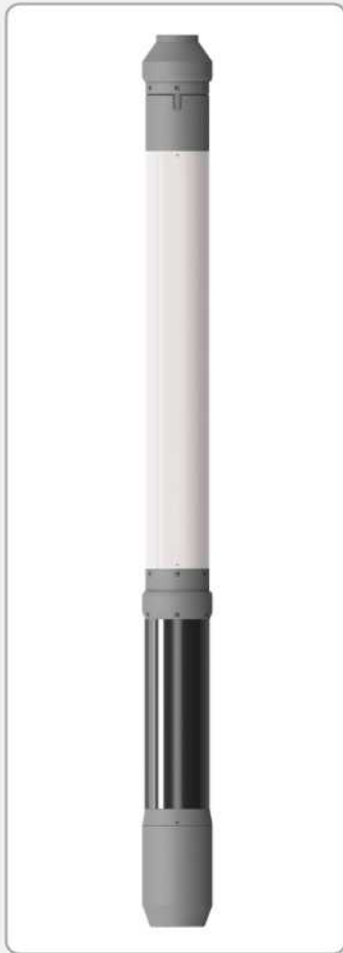
The Wel-lok CRT (Cement Repair Tool) has been developed to eliminate sustained casing pressure, or casing vent flow, in cemented annuli. Unlike traditional methods of perf and squeeze or perf and wash, this tool does not require any surface pumping pressure to squeeze or circulate the sealing material into place. The tool is also run rigless on electric line, sealing through casing perforations, so section milling is not required.

The bismuth-based alloy has no porosity and solidifies to create a seal in minutes as opposed to hours with traditional cement and resins, eliminating the possibility of a micro-annulus being formed to allow future gas migration. If full bore access is required, it can be milled out and still maintain a gas tight seal in the annulus.

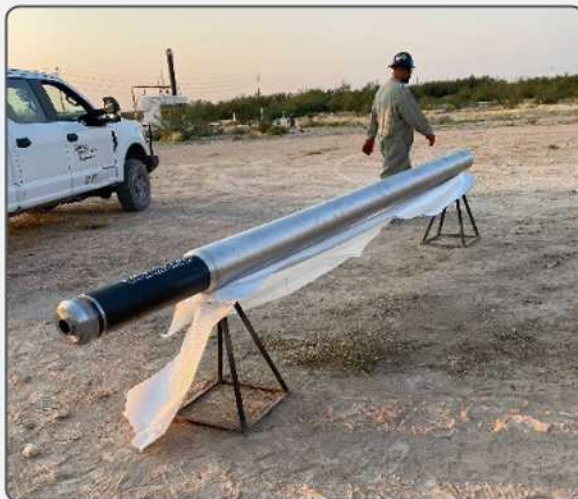
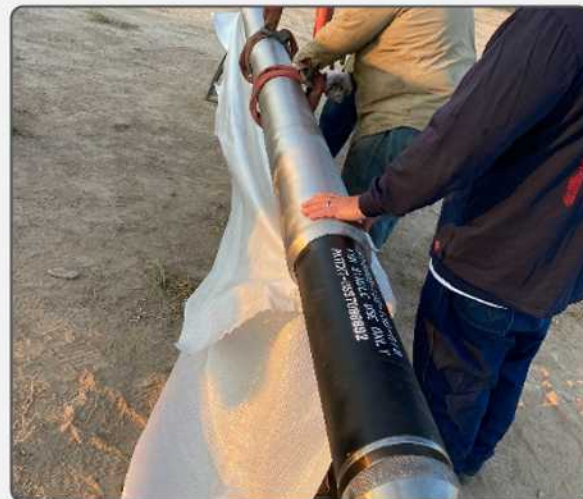
The well was successfully bubble tested, resulting in zero bubbles at surface and allowing the operator to complete the permanent well abandonment. With bubbles and pressure successfully eliminated from this well, BiSN moved on to the next well for the same operator with the same issues of sustained casing pressure and surface gas bubbles.
